Design Change Request Sheet

Parts Name : Door inner panel	Sub System : 48A-72	System : A
-------------------------------	---------------------	------------

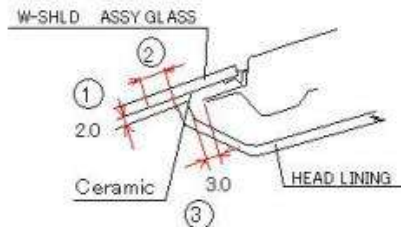
HEADELINING ASSY × WINDSHILD

① GAP

UP TO 2.0

② HEADELINING ASSY ×
 CERAMICS Parallel

③ HEADELINING ASSY ×
 BODY GAP

TAUCHING
 REJECTION

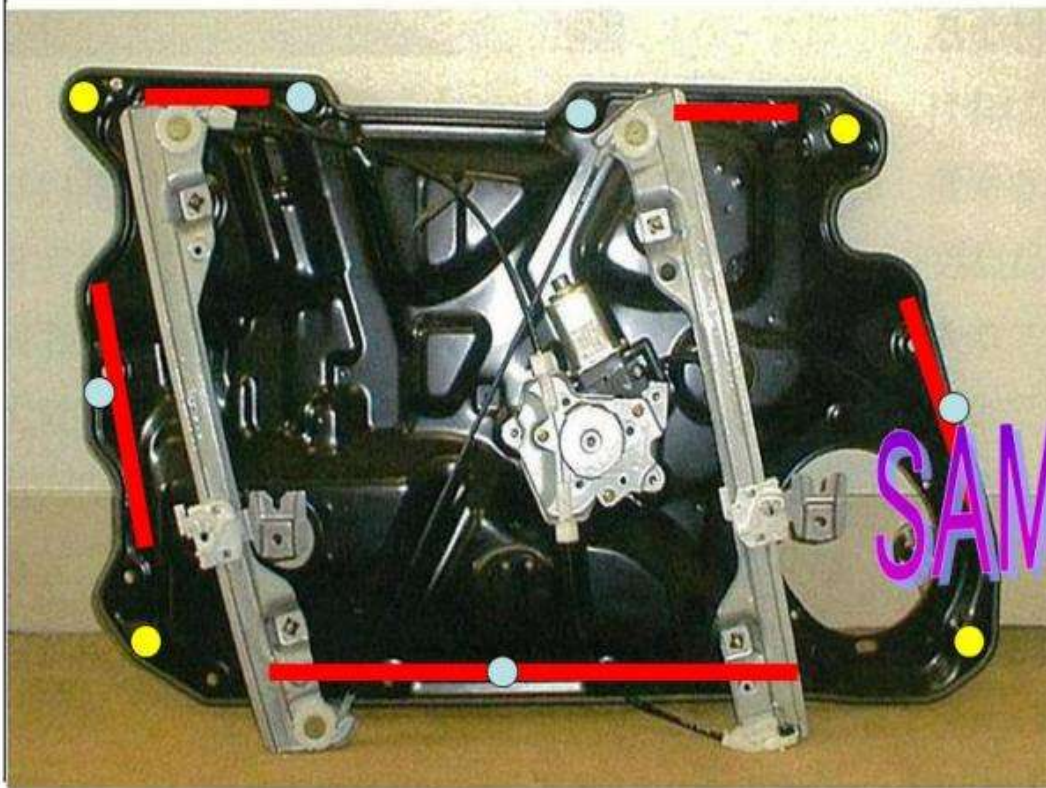
Analysis

Door Panel Inner set on the Door inner frame with 18 Bolts now.

For assembly time saving, combination fitting required.

Bolts ●

Tape

Clip ●

Need change combination fitting the bolts, clips and the Adhesive tape. At least 4 bolts needed.
